Comparison of rolling contact fatigue damage between railway wheels and twin-disc test specimens

N.F. Strey, A.B. Rezende, R.S. Miranda, S.T. Fonseca, P.R. Mei, C. Scandian

To appear in: *Tribology International*

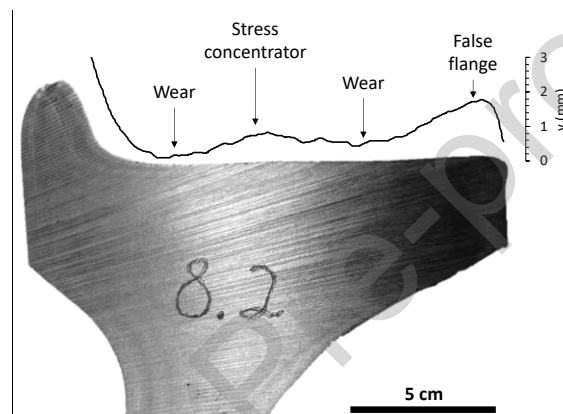
Figure 5 presents a photograph of the radial section (refer to Figure 4b) of the wheel tread shown in Figure 6a (refer to Figure 4a), as well as its geometric profile, measured from image analysis via the software ImageJ1 [48]. The profile reveals that two depressions, caused by wear in two different rolling bands, generate a stress concentrator located in the center of the wheel tread and a false flange close to the chamfer. Therefore, it is no coincidence that shelling originated in the central region of the tread. The presence of the false flange may explain the microcracks observed near the chamfer of the wheel in Figure 6a, in addition to the lateral plastic flow of the tread that causes a protrusion of material at the rim chamfer. Thus, defects could be mitigated by improving the dynamics of the wagon truck, to distribute the surface wear more evenly along the tread, reducing the concentration of stresses and promoting the truncation of cracks generated by RCF.

Figure 5 – Photograph of a radial section (Figure 6b) after sawing the wheel and tread profile obtained through image analysis. The region of the wheel tread where a geometric stress concentrator is observed corresponds to the region containing the shelling defect in this wheel.

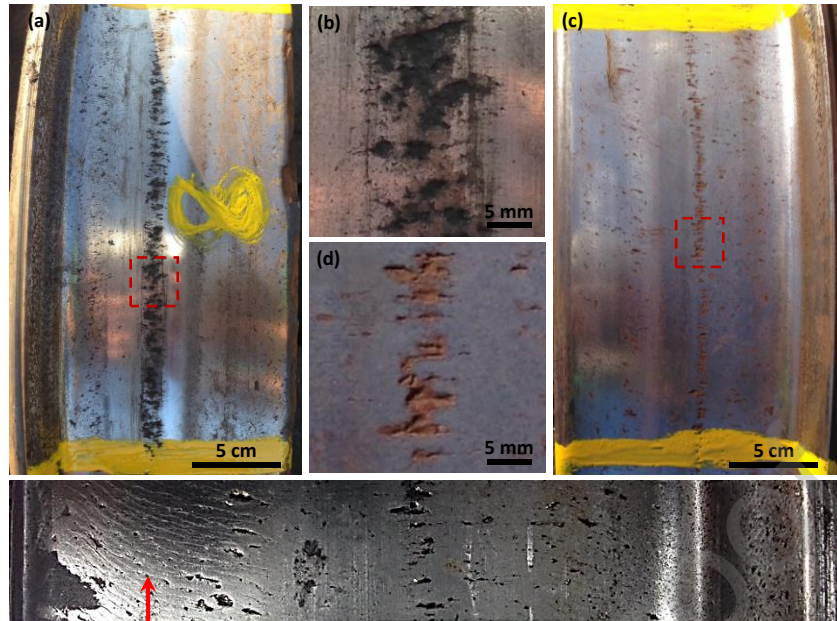
Rolling surfaces of two moderately shelled wheels, one forged and one cast, are shown in Figure 6. Over almost the entire circumference and width of the surfaces, a characteristic metallic luster predominates, which suggests the continuous exposure of new surfaces by wear. Shelling, on both wheels, appears in the central region of the tread along much of the circumference, with greater severity in the cast wheel (Figure 6a) than in the forged wheel (Figure 6c), in this particular case. Shelling fracture surfaces are shown in greater magnification in Figure 6b and Figure 6d, for the cast and forged wheels, respectively. They are corroded and surrounded by a network of very fine surface microcracks, almost imperceptible to the naked eye, which are perpendicular to the direction of rolling. Microcracks of greater superficial extension and inclined in relation to the rolling direction, associated with shelling in its incipient stage (i.e., tread cracking), can be seen near the chamfer (at the field side of the rim) on the forged wheel (Figure 6e).

Figure 6 – Macroscopic aspect of shelling defect on wheel's tread after service. (a) Cast wheel, flange on the left. (b) Magnification of the region demarcated in (a). (c) Forged wheel, flange on the right. (d) Magnification of the region demarcated in (c). (e) Magnification of the entire length of the wheel tread shown in (c), arrow indicate rolling direction for both wheels.

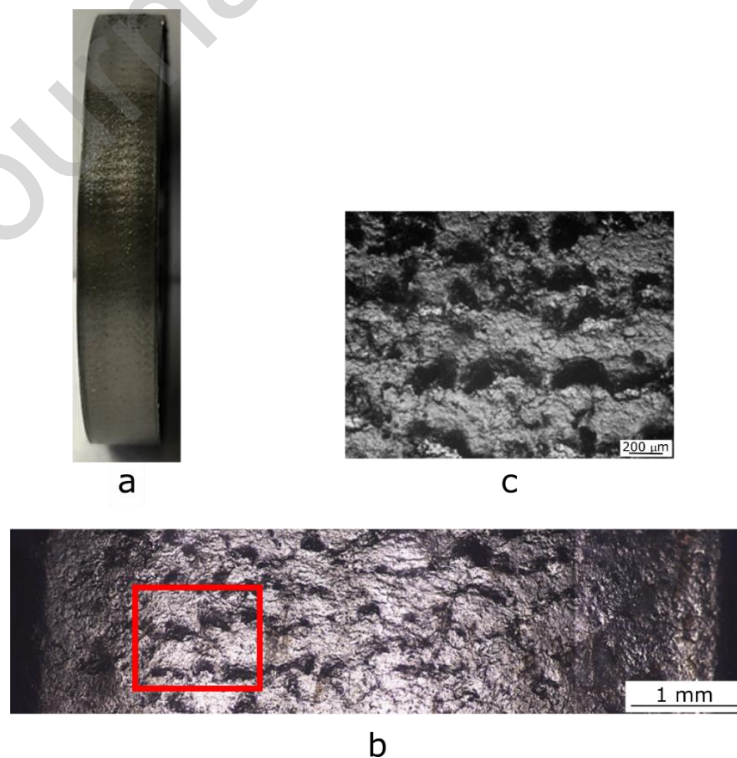
Figure 7 presents the integrity of a disc's rolling surface after 100,000 cycles. The delamination present in the disc surface is similar to those identified in the Figure 6e (indicated by red arrow). The micrography (Figure 7b) showed several marks in the disc surface, and the dark areas may be delamination or removed particles. These superficial characteristics were also found in twin-disc tests with slip ratio of 20% [49].

Figure 7 – Macroscopic aspect of shelling defect on discs after 100,000 cycles. (a) Discs tread (b) Magnification of the region in OM. (c) Magnification of the region demarcated in (b).

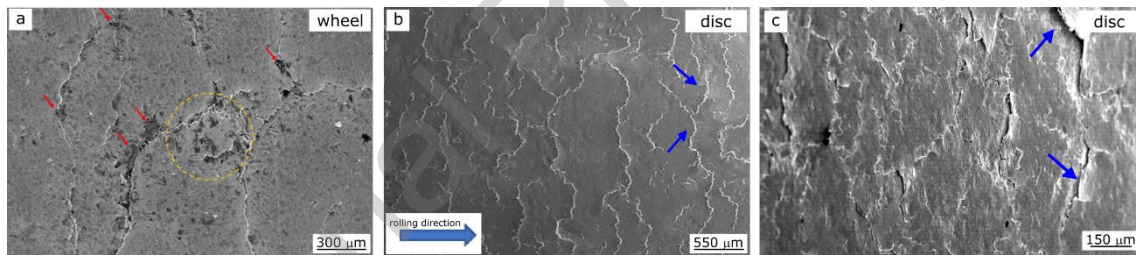
SEM images of wheel's and disc's surfaces (Figure 8) reveal that there are networks of RCF cracks. Both the actual wheel and the disc specimens were submitted to high magnitude cyclic stresses under unlubricated rolling-sliding conditions and there is direct evidence for the presence of surface and subsurface cracks, as well as microstructural distortion and strain-hardening of a heavily plastically deformed layer, as will be seen in the following sections, indicating that ratcheting is the main deterioration mechanism in both cases. This regime is characterized by the accumulation of plastic deformation at each cycle that results in depletion of the material's deformation capacity and, consequently, nucleation of superficial fatigue cracks [37,50]. A subsequent delamination process results in material detachment (i.e., wear) when the crack trajectory met the surface again [10,51–53]. Additionally, in wheels (Figure 8a), the red arrows indicate the presence of oxidation products located in crack's mouths, while, in disc specimens, there was no such evidence of oxidation.

Figure 8 – (a) SEM micrograph of the tread surface of a forged wheel, showing the pattern of cracks (tread checks). The region demarcated by the circle comprises a particle, on the verge of detaching itself from the surface. The arrows indicate dark regions, which correspond to oxide material that forms or deposits at the cracks' mouths. (b) SEM images of a disc's rolling surface after 100,000 cycles. (c) SEM image of the same sample in (b) with a slightly tilted angle, highlighting delamination (blue arrows).

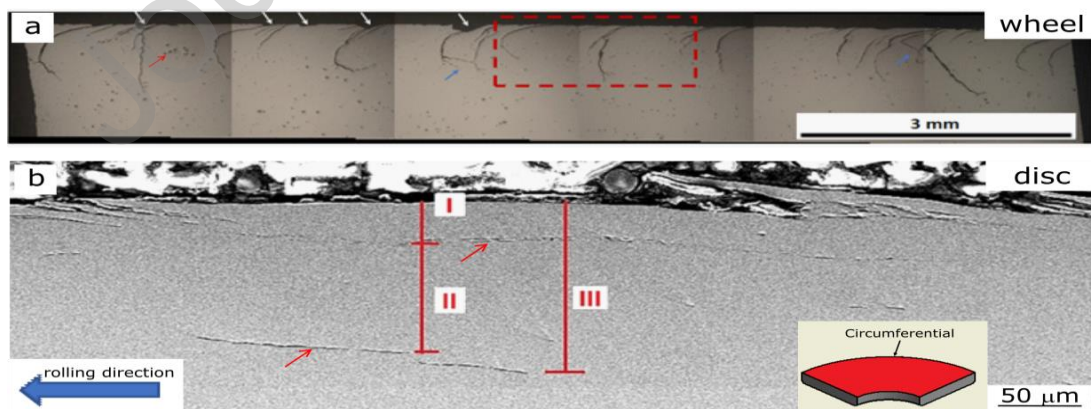
Figure 9a shows a micrograph of the polished circumferential section of a forged wheel. A population of cracks is present. Virtually all of them culminate on the surface, suggesting that, likely, their genesis must be mostly superficial. For high loads and high friction coefficients (e.g.,  $\mu > 0.3$ ), the maximum principal shear stresses point is located at the surface of the rolling bodies. On the other hand, for lower friction coefficients, say  $\mu < 0.2$ , the point is located at the subsurface. These stresses are the ones responsible for the yield, strain-hardening and subsequent plastic depletion of the material during cyclic loading, resulting in microfracture by ratchetting. Therefore, surface induced cracks are predominant due to the high loads and expected high friction that is typical of unlubricated rolling contacts [61].

Each crack forms a shallow angle in its encounter with the surface,  $14^\circ$  to  $20^\circ$ , however, as it deepens in the material, the inclination progressively increases until the trajectory is perpendicular to the surface. At this point, some cracks branch into two propagation fronts: one that remains perpendicular and the other that tends to have smaller angles, or even are parallel to the surface (blue arrows). The intersection of a deeper parallel branch with an adjacent crack, which propagates perpendicular to the surface, can cause the removal of a large portion of material (shelling defect). However, the removal of small particles, through the intersection of cracks closer to the surface, is more frequent (white arrows). Figure 8a provides additional evidence to support this hypothesis, showing a small particle on the verge of detaching from the surface.

Figure 9 – (a) Optical micrograph of the polished circumferential section of a forged wheel tread after service. White arrows indicate regions where small particles have been removed, while blue ones point to intersections of cracks in the subsurface. (b) Scanning electron micrograph of the polished circumferential section subsurface of the disc after 100,000 cycles. The red lines indicate the cracks distance to surface. I = 30  $\mu\text{m}$ ; II = 112  $\mu\text{m}$ ; III = 130  $\mu\text{m}$ .

The maximum crack depth, evaluated in the circumferential section of wheel treads, lies in the ranges of 0.1-0.7 mm and 0.1-1.0 mm for cast and forged wheels, respectively. Due to the limited sampling, it is not possible to state that there is a significant difference in the crack depth observed in forged and cast wheels. However, the somewhat similar range of depths may be characteristic of the contact conditions found at the railway.

Figure 9b presents the circumferential section micrograph of a pearlitic disc specimen. Likewise that on the wheel analysis, the disc presented cracks that originated on the surface and propagate to the subsurface of the disc, which configured the delamination process [50, 51]. However, these cracks did not propagate to a great depth as in the wheel. The crack angles were between  $10^\circ$  and  $12^\circ$  and they were very close to that found in the forged wheel (Figure 9a). The values of crack angles were also similar to found in other laboratorial twin-disc tests with slip ratios close of 0.75% [62–64]. Thus, when correlating the cracks of the two analyzed conditions, it is possible to conclude that the twin-disc test simulates a first stage of the crack's formation process. Wheel presented cracks in a more advanced propagation stage, which was evidenced by the much deeper cracks.

The micrograph of Figure 9a still reveals that the metallurgical cleaning of the steel is not good, with levels of heterogeneities (non-metallic inclusions plus micro-porosities, indicated by the red arrow) around 1.0%, well above the 0.1% recommended by the AAR M-107/M-208 specification [42], although, in some cases, the assessed region has not coincided with that required by the standard. Similar levels were found for all evaluated wheels, whether forged or cast. Small deviations in the trajectory seem to cause the crack tip to meet these heterogeneities in the material, as they represent local stress concentrators. This inadequate metallurgical cleaning was also found in the twin-disc specimens (Figure 9b). Inclusions and voids, indicated by red arrows, were points of crack nucleation in the disc's subsurface. The cracks that begin in voids, inclusions, and sulfides (mainly MnS) propagate parallel and close to the contact surface and may accelerate the delamination, if the crack branch and coalesce up to the surface [66–68].

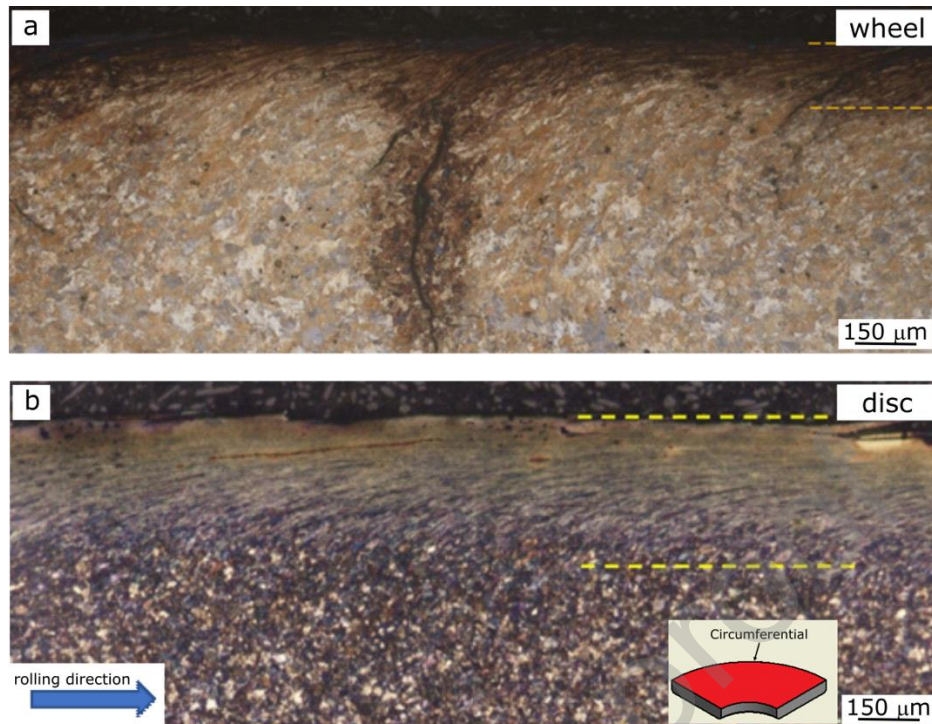
Figure 10a shows the microstructure of the circumferential section, showing that the crack appears in a plastically deformed layer on the surface, whose thickness is in the 127-250  $\mu\text{m}$  range (95% confidence interval). The crack follows a trajectory that is tangent to the deformation lines until it finds the preserved microstructure at the aforementioned depth, which was subjected only to elastic stresses. As state before, the crack trajectory can either remain perpendicular to the surface, through the preserved microstructure, or is capable of branching, where its trajectory runs close to the interface between the plastically deformed layer and the non-deformed microstructure. Similar behavior is shown for the disc after 100,000 cycles in the Figure 10b. In the disc, there was a severe hardening in the surface, whose thickness varied in 255-270  $\mu\text{m}$  range (95% confidence interval). The curvature of the deformed layers equally follows the rolling direction due to the tangential forces promoted by the contact load and the slip effect [49,69,70]. The thickness for both studied conditions was close, which proves the laboratorial test capacity to simulate some wheel damage characteristics.

Figure 10 – (a) Magnification of the red box in Figure 9a (OM), circumferential section of a forged wheel tread after service (Nital 2% etchant). (b) Optical micrograph of the circumferential sectional view of the disc after 100,000 cycles (Nital 2% etchant).

The effects of the contact stress in the subsurface can be divided in three regions [71]. Referring to Figure 10, in a first layer near the surface (delimited by dashed lines) there is severe plastic deformation. Just below it, a transition region takes place, where elastic contact and residual stresses compete. Finally, a deeper region is characterized by contact stresses of negligible magnitude. The explanation correlates with the hardness profiles of Figure 14, where the disc initial hardness is only reached at a 0.5 mm depth, while the OM images reveals that the plastic deformed layer has a thickness of only 290 μm. The same is true for wheels, where some strain-hardening is observed up to 1 mm depth, while plastic deformed layer is only 255-270 μm thick.

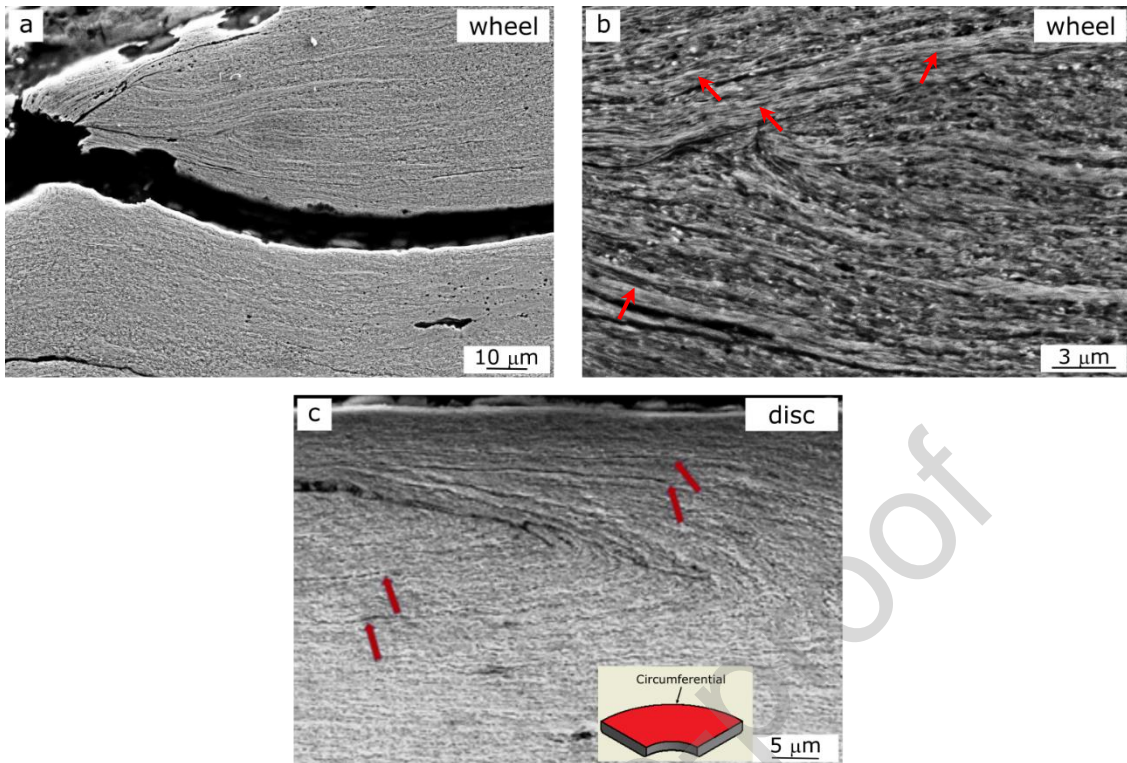
The high deformation of the wheel steel pearlitic microstructure is shown in greater detail in Figure 11a-b, revealing that a significant in-service refinement took place near the rolling surface. The same effect is found in the disc subsurface after the twin-disc test (Figure 11c). The cementite lamellae align to the rolling direction, become thinner, more closely spaced, and also fractured [46,71]. There are very fine microcracks (indicated by red arrows) close to surface, where the deformation is more severe. These microcracks regularly propagate in the grain boundary ferrite and in the ferrite of the pearlite, which are aligned with the rolling direction [72,73]. The wide crack shown in Figure 11a is the one giving rise to the detachment of material (shell).

Figure 11. SEM of the radial section near the flange root of a cast wheel after service (2% Nital etching). (a) Region of the mouth of a superficial crack. (b) Magnification of the (a), showing great deformation of the microstructure and very fine microcracks running through the ferrite phase. (c) Scanning electron microscopy (SEM) image of the circumferential sectional view of the disc after 100,000 cycles (2% Nital etching). The red arrows indicate the microcracks.

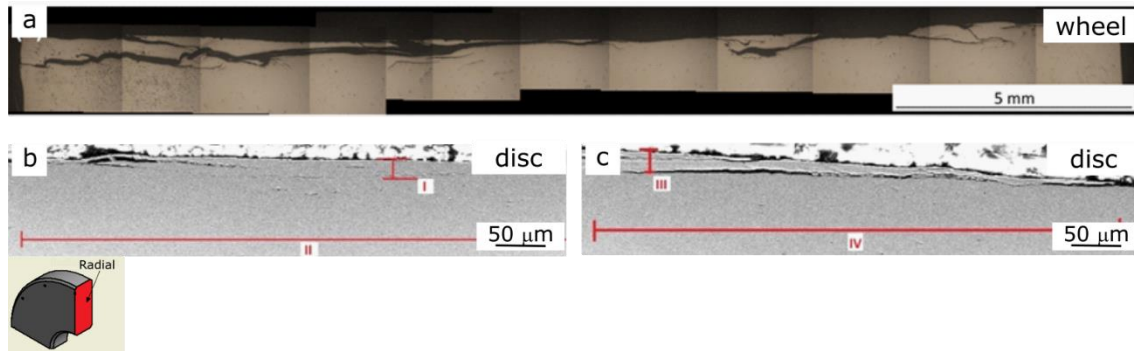
Figure 12a shows the radial section of the tread of the same wheel shown in Figure 9a. Subsurface cracks follow, parallel to the surface, with a much greater extension, from 5 to 15 mm, in the direction perpendicular to the rolling direction, which agrees with the superficial macroscopic observations (Figure 5). Portions of material at the surface can be observed without any connection with the material below them, which implies the imminence of shelling formation.

Figure 12b e Figure 12c illustrates the SEM images of the radial section of the pearlitic disc. Once again, there is a correlation between the twin-disc tests and the actual wheel. Figure 12b shows a crack that propagated parallel to the surface. The crack length is 850  $\mu\text{m}$  and the depth is up to 31  $\mu\text{m}$ . The crack illustrated in the Figure 12c has a smaller length of 500  $\mu\text{m}$  and the depth of 20  $\mu\text{m}$ . In the latter case, the propagation process was in an intermediate stage, since the crack begin closer the surface and propagates into the disc. This propagation behavior is similar to the one found in wheels (Figure 12a). From Figure 9 and Figure 12, it is possible to conclude that the crack propagation process is directionally-dependent, for both the disc and the wheel, and result in fracture surfaces typical of shelling defect (or delamination).

Figure 12 – (a) Optical micrograph of the polished radial section of a forged wheel tread after service. (b), (c) Scanning electron micrograph of polished radial sections disc specimens after 100,000 cycles. The red lines indicate cracks lengths or depths. I = 31  $\mu\text{m}$ ; II = 850  $\mu\text{m}$ ; III = 20  $\mu\text{m}$ ; IV = 500  $\mu\text{m}$ .

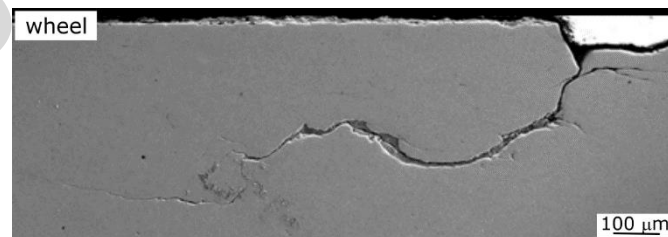
The presence of water inside RCF cracks is common in railway's wheel-rail contact, due to rain or moisture. In its liquid state, water, when pressurized inside a crack by the rolling contact stresses, can accelerate its propagation through mode I loading (opening mode). Water and moisture present in the air are also able to corrode the faces of a crack originated from RCF, given the high susceptibility of carbon steel to corrosion. Figure 13 and Figure 8a corroborate this hypothesis, showing the presence of corrosion products inside cracks present on the wheel's rolling surface. Corrosion can affect fatigue processes, so also RCF, in different ways: i) cathodic or anodic reactions at the crack tip that accelerates crack propagation [74]; ii) wedging by corrosion products inside cracks can reduce the stress intensity amplitude (benefic effect), but increase its magnitude (malefic effect, [75]); iii) iron oxides have a relatively low shear resistance in sliding motion (compared to a metal-metal contact), promoting a lubricating effect between crack faces and, as a consequence, enabling mode II crack propagation (shear mode). For the tested conditions, twin-disc tests did not replicate the corrosive process occurring inside RCF cracks. This can be viewed as a limitation to the simulation of actual wheel-rail tribosystem's behavior, although many other important features are still present and give valuable information about it.

Figure 13 - SEM of the radial section at flange root of a cast AAR Class C wheel. Corrosion products accumulate inside the crack.

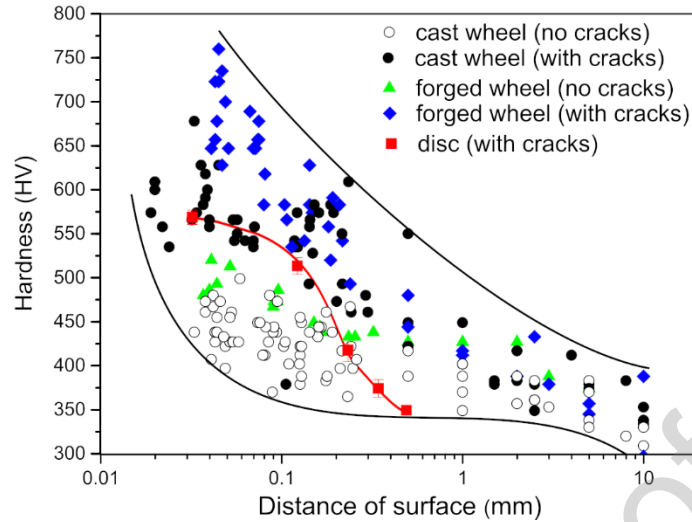
The considerable microstructural plastic deformation causes strain-hardening of a surface layer. The graph in Figure 14 shows microhardness profiles for wheels that showed shelling, or surface microcracks, and for wheels with “smooth” surfaces, i.e., without the presence of these defects, whether forged or cast. All wheels showed some level of hardening, presenting greater hardness close to the surface than in the bulk, which is 300-380  $\text{HV}_{0.05}$ . However, surfaces that showed shelling or microcracks invariably strain-hardened more: microhardness at about 0.04

mm depth was in the range between 550 and 760 HV<sub>0.05</sub>, while for smooth surfaces it was between 400 and 520 HV<sub>0.05</sub>. Therefore, the higher hardness level of surfaces with microcracks or shelling indicates that the deformed layer has been plastically depleted, not supporting any increase in deformation without causing fracture, which is further evidence for ratcheting phenomenon. Depending on the evaluated depth, the microhardness threshold between ratcheted and “smooth” surface varies.

Figure 14 also shows evidence of strain-hardening on twin-disc test specimens. All hardness points for twin-disc tests specimens are inside of the hardness range found in wheels. At 0.03 mm depth the hardness was 570 HV<sub>0.3</sub> (hardness increment of 60%) and the value is in the range observed for shelled wheels at the same subsurface depth (Figure 14). Therefore, the twin-disc test is able to simulate the ratcheting mechanism caused by exhaustion of plasticity close to the surface. In both field and laboratory conditions, the farther from the surface the magnitude of contact stress are reduced, that results in less strain-hardening at greater depths. However, the strain-hardened layers of shelled wheels are much thicker than the ones of twin-disc test specimens, about 1 mm for the former versus 0.5 mm for the latter. The difference can be explained in terms of different residual elastic stress fields between the two, which is expected to be much greater in the wheels.

Figure 14 – Vickers microhardness profiles along the tread of the forged and cast wheel and hardness profile of the radial section of the disc ( $HV_{0.3}$ ) (■). Surfaces that presented shelling or tread checking ( $HV_{0.05}$ ) (● ◆) and a relatively smooth surface, i.e., without cracks ( $HV_{0.05}$ ) (○ ▲).

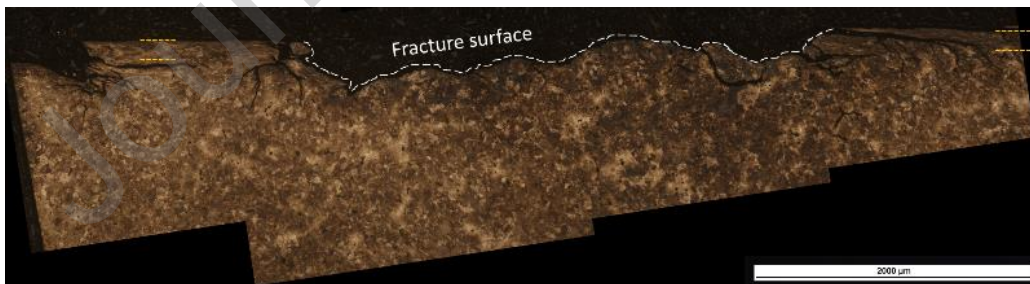
Fracture surfaces, after the formation of a shelling defect in wheels, are quite irregular, as shown in Figure 15. Below it there is no plastically deformed material, which corroborates the observation of crack propagation parallel to the surface below the heavily strain-hardened layer. The defect edges become stress concentrating points and give rise to a new network of cracks that contribute to the material removal process, meaning that the defect increases in size by expanding its edges. This suggests that shelling progresses at an accelerated rate, since it is a feedback process: the greater the perimeter of the edge of the fracture surface, the more stress concentrating points are generated which, in turn, promote new material removal, expanding the perimeter of the edge, and so on. Understanding the edge effect can help determine the optimum timing for reprofiling of wheels, from economic and safety points of view.

Figure 15. Optical micrograph of the circumferential section of the tread of a cast AAR Class C wheel (etched in Nital 2%). White dashes highlight the fracture surface of a shelling defect and yellow dashes denotes the plastically-deformed layer.
